Manhole Inspection Summary

Manhole # S41AA_017MH

Insp Date: **11/11/08 9:31 AM**

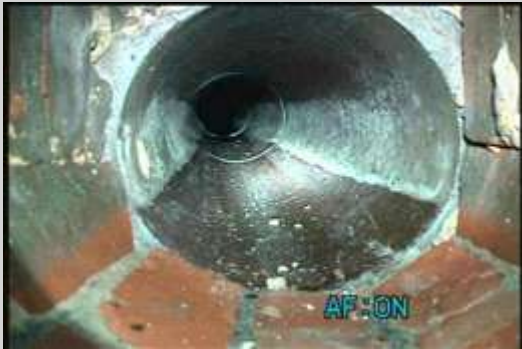
12 O'Clock Outflow

8 in. Circular Gravity Sewer
Pipe Out @ 12 O'Clock

Pipe Material: **Clay** ☐ Pipe Lined

Infiltration: **None** Pipe Seal Cond: **Unknown**
